Navajo Abandoned Uranium Mine

Site Screen Report

Tree Mesa AUM Site

August 2010

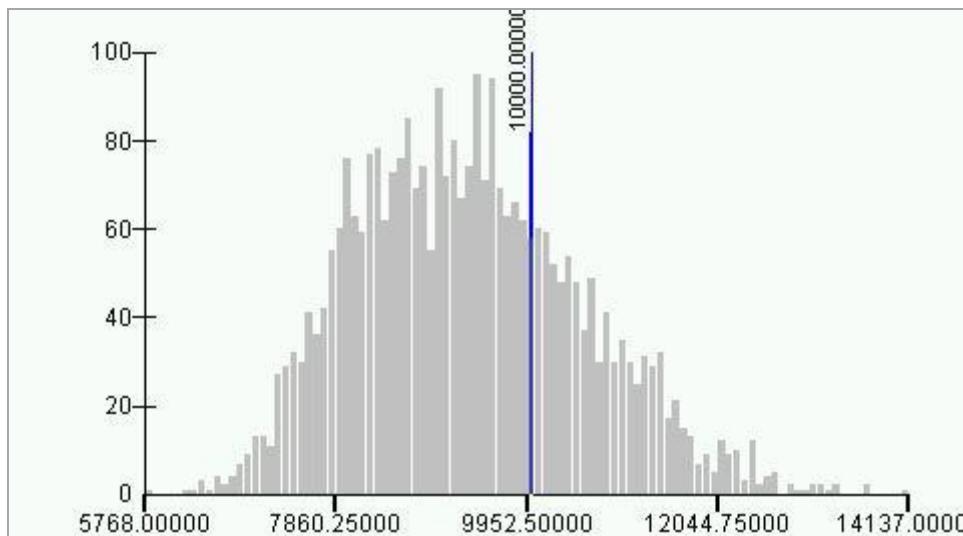
The following chart and statistics were generated by ESRI ArcGIS 9.3.1, and show the general distribution of the site gamma radiation measurements. The horizontal X axis represents the gamma radiation reading levels in cpm (lowest levels to the left). The vertical Y axis represents the frequency of each gamma radiation level.

Count:	3080
Minimum:	5768.00000
Maximum:	14137.00000
Sum:	28687365.00000
Mean:	9314.07955
Median:	9227.00000
Standard Deviation:	1251.88033

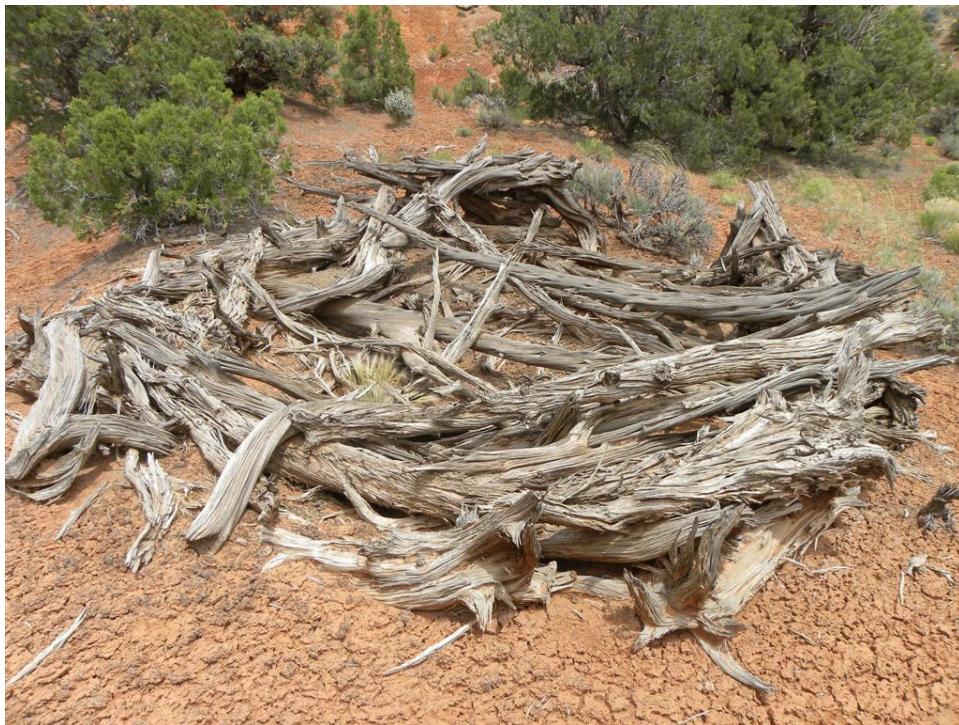
0 to 200 feet: 2 hunting structures approximately 200 ft downgradient, S of site

Photo 1. Tree Mesa site, structure S of site

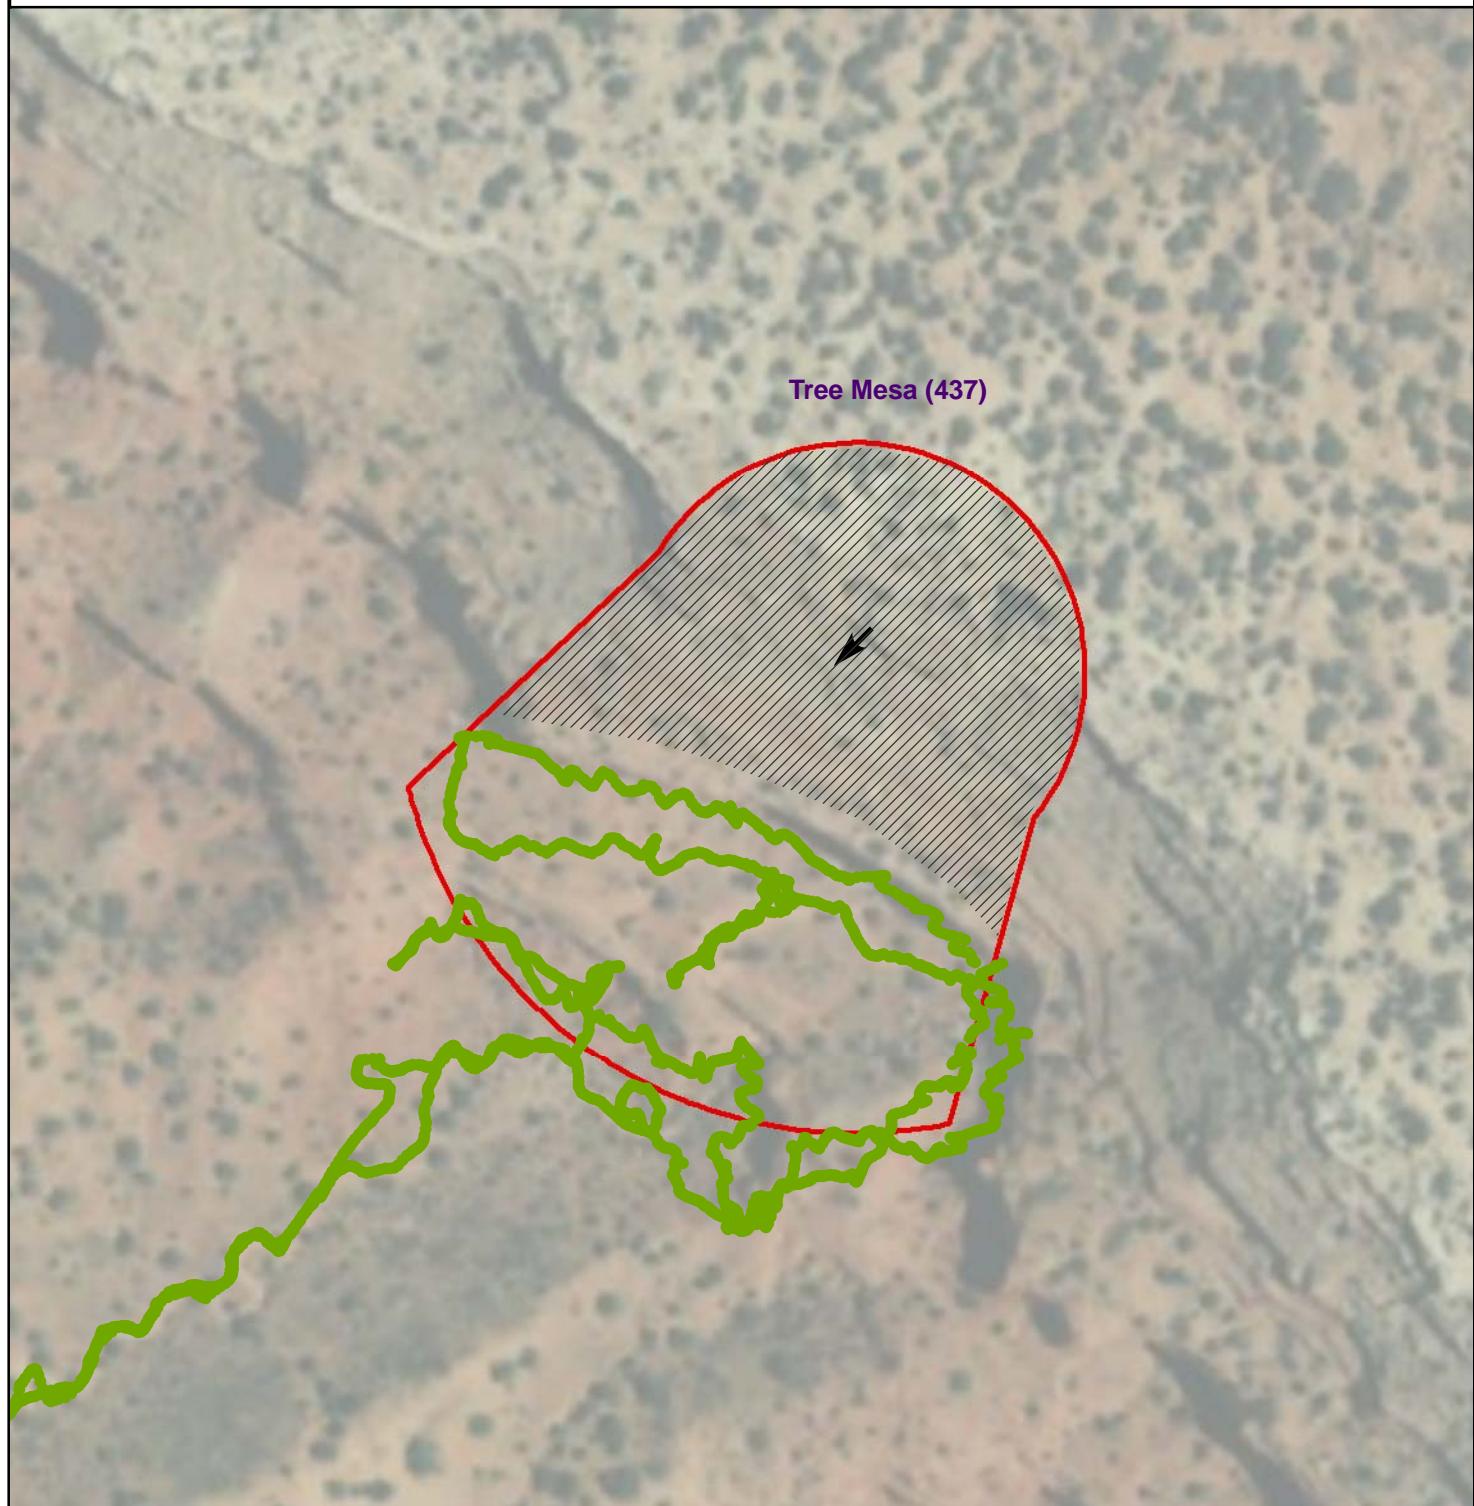
Figure 1 - Gamma Radiation Measurements, Above Two Times Background
Tree Mesa (437)
Sweetwater Chapter, Navajo Nation

A total of 3,080 gamma radiation measurements were collected from the mine site, ranging from 5,768 cpm to 14,137 cpm. The measurements are represented in Figures 1 and 2.
